LIFE GoodWater IP approach to planning and implementing measures for improvement of water quality – agriculture land

Ainis Lagzdins, Dr.sc.ing., professor
I.Siksnane, R.Sudars, A.Veinbergs, L.Grinberga
Latvia University of Life Sciences and Technologies
Department of Environmental Engineering and Water Management
e-mail: ainis.lagzdins@llu.lv

EU LIFE Programme integrated project
“Implementation of River Basin Management Plans of Latvia towards good surface water status”

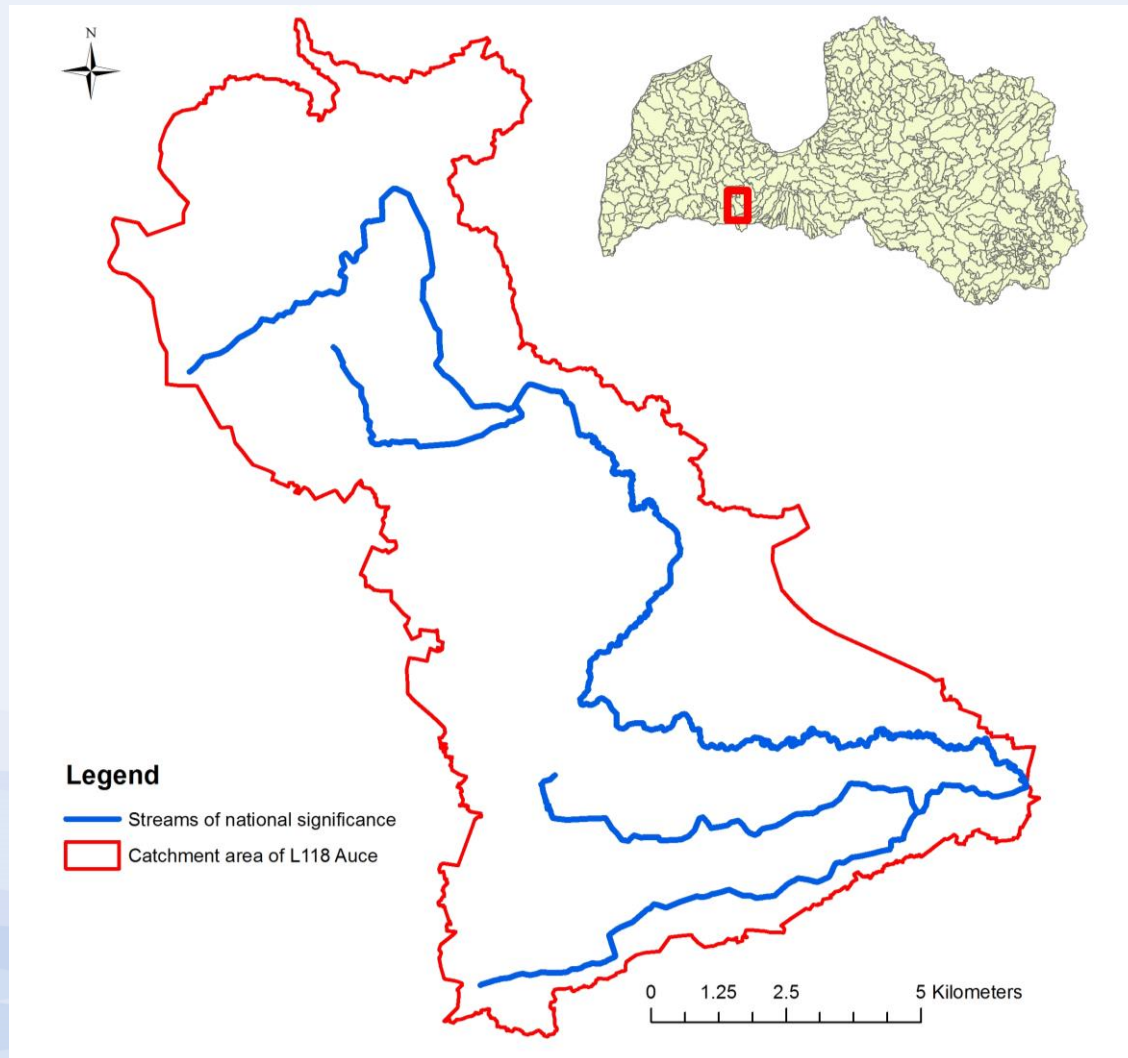
Streams of national significance - L118 Auce

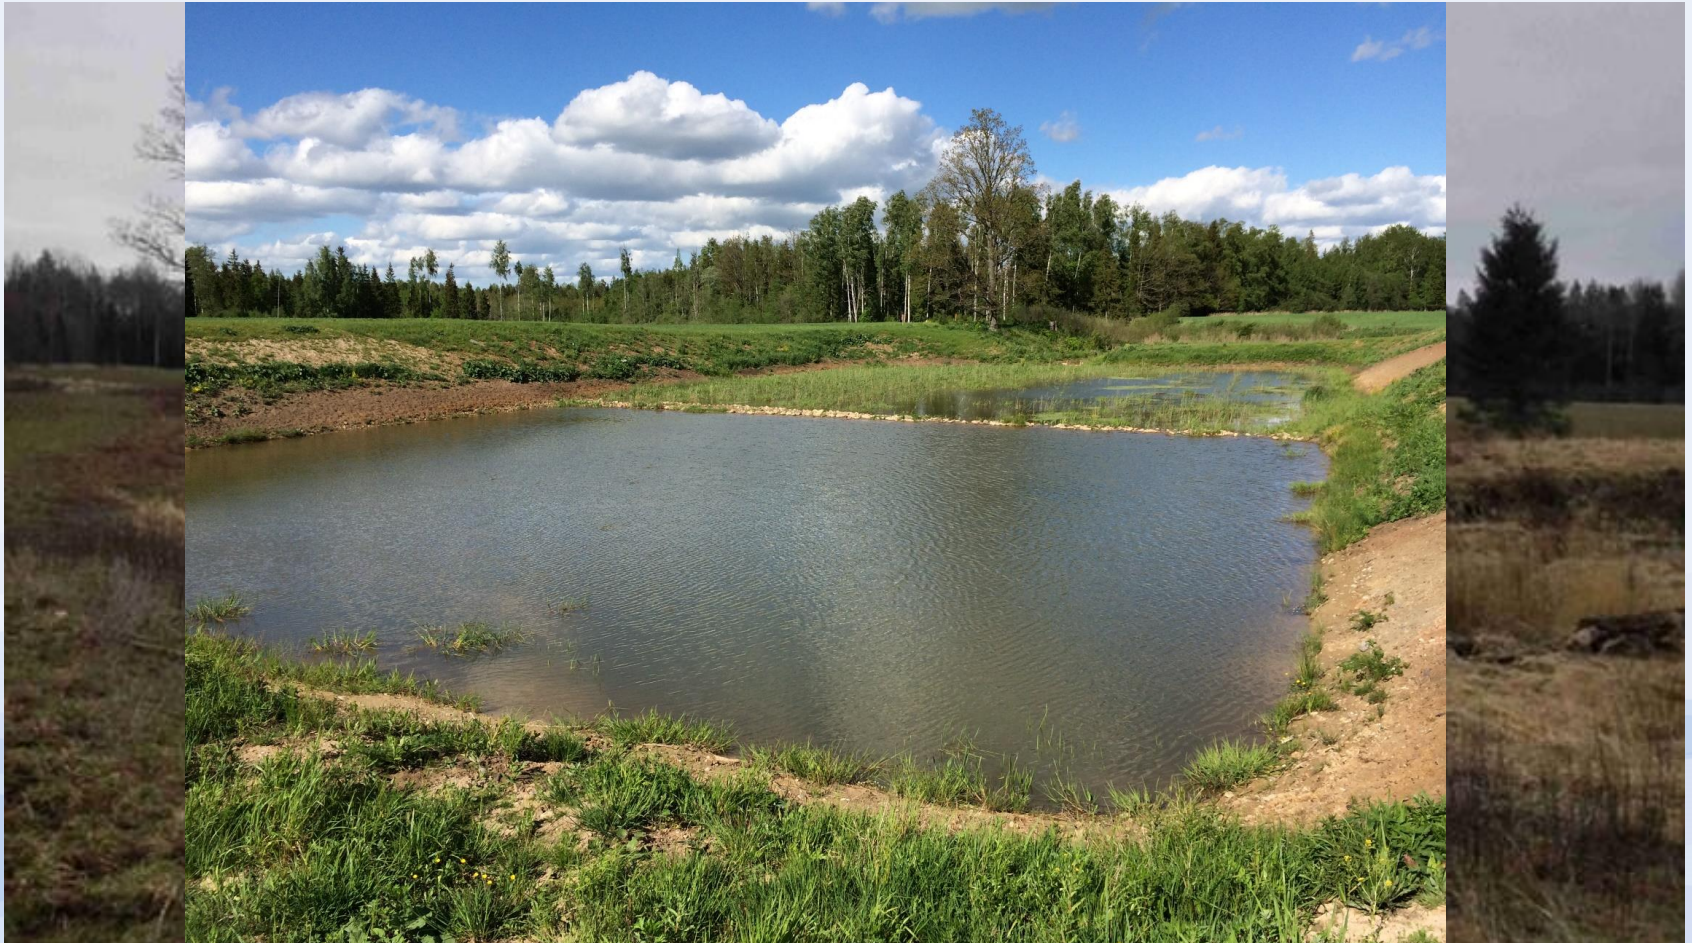
The examples of suitable locations for implementation of sustainable and environmentally friendly drainage systems - the constructed wetland at the Vilcini-1 Farm
